**Flood Control Project Maintenance
Levee Inspections**

Fall 2018 Levee Maintenance Deficiency Summary Report

Sacramento River Basin

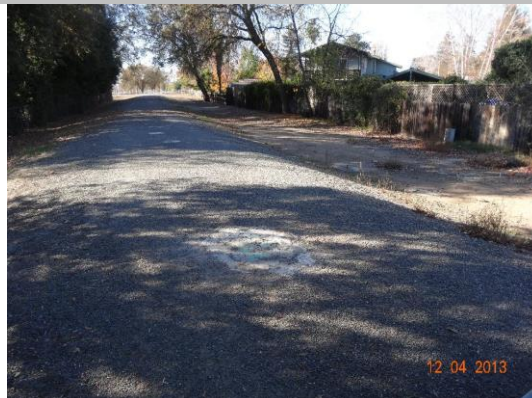
Photo 3 of 3 : UCIP_FA_2018_26298_47568.jpg

Comment Code						
Inspector Comment						
FS_ID:26298 DS_ID:24567 EP_NO: 3599A Repair Type: Non-Urgent Crossing Status: Found UCIP Comments: Need to determine status of structure. Need to coordinate with owner to determine maintenance records to confirm integrity. FIELD_STRUCT_DESC: [River Walkway Station] 2 of 3: 36-inch concrete encased pipe through the levee, 6.9 feet below the crown. Two cutoff walls around pipe in line with each shoulder. Slide gate in concrete gate structure at landside (LS) toe. Sewage treatment plant on waterside (WS). Control valve in concrete box on the WS. Contact: Sacramento Regional Office 875-9400; Oscar Starks (Supervisor) 916-204-5143; Troy Shurock 916-599-2413. (one 54-inch and two 42-inch pipes authorized under Permit No. 3599B, 1964-County of Sacramento, Department of Public Works Northeast Sacramento County Sanitation District) [Additional Reference(s): DWR Levee Log, 2002] FS Date: 12/4/2013

Overview of levee crown with grout holes visible at the crown along pipe alignment.

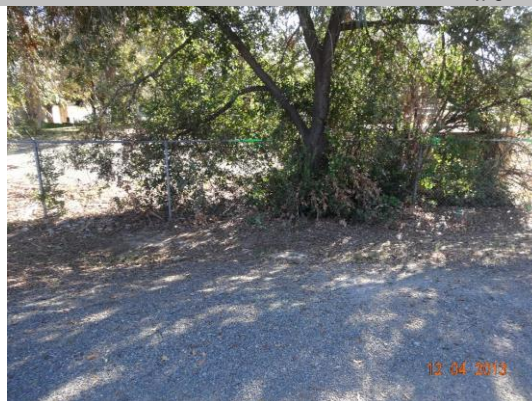
Photo 2 of 3 : UCIP_FA_2018_26426_47980.jpg

Comment Code						
Inspector Comment						
FS_ID:26426 DS_ID:24098 EP_NO: 3599 Repair Type: Non-Urgent Crossing Status: Indicator Found UCIP Comments: Need to determine status of structure--unable to determine if crossing is still being used. Underground service alert (USA) flag indicates 60 inch pipe through levee. Need to clarify. FIELD_STRUCT_DESC: [River Walkway Station] 3 of 3: 54-inch concrete encased pipe through the levee, 8.5 feet below the crown. Two cutoff walls around pipe in line with each shoulder. Slide gate in concrete gate structure at landside (LS) toe. Sewage treatment plant on waterside (WS). Control valve in concrete box on the WS. Contact: Sacramento Regional Office 875-9400; Oscar Starks (Supervisor) 916-204-5143; Troy Shurock 916-599-2413. (one 54-inch and two 42-inch pipes authorized under Permit No. 3599B, 1964-County of Sacramento, Department of Public Works Northeast Sacramento County Sanitation District) [Additional Reference(s): DWR Levee Log, 2002] FS Date: 12/4/2013

View of Underground Service Alert (USA) markers and flags confirming buried sewer lines.

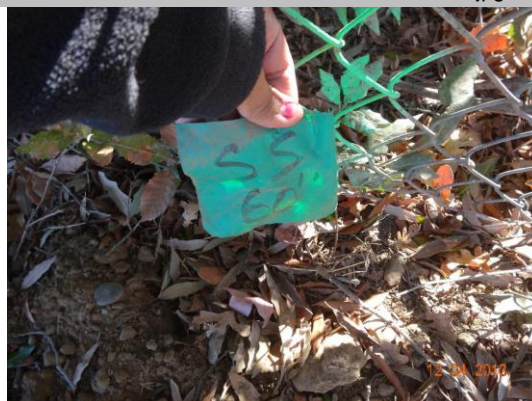
Photo 3 of 3 : UCIP_FA_2018_26426_47984.jpg

Comment Code						
Inspector Comment						
FS_ID:26426 DS_ID:24098 EP_NO: 3599 Repair Type: Non-Urgent Crossing Status: Indicator Found UCIP Comments: Need to determine status of structure--unable to determine if crossing is still being used. Underground service alert (USA) flag indicates 60 inch pipe through levee. Need to clarify. FIELD_STRUCT_DESC: [River Walkway Station] 3 of 3: 54-inch concrete encased pipe through the levee, 8.5 feet below the crown. Two cutoff walls around pipe in line with each shoulder. Slide gate in concrete gate structure at landside (LS) toe. Sewage treatment plant on waterside (WS). Control valve in concrete box on the WS. Contact: Sacramento Regional Office 875-9400; Oscar Starks (Supervisor) 916-204-5143; Troy Shurock 916-599-2413. (one 54-inch and two 42-inch pipes authorized under Permit No. 3599B, 1964-County of Sacramento, Department of Public Works Northeast Sacramento County Sanitation District) [Additional Reference(s): DWR Levee Log, 2002] FS Date: 12/4/2013

USA marker indicates 60 inch line through levee.

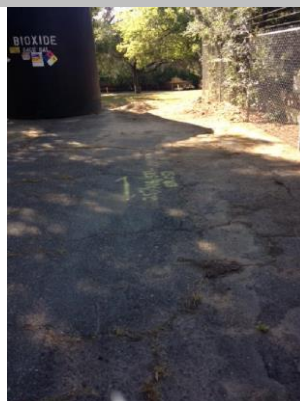
Photo 1 of 3 : UCIP_FA_2018_50053_75902.jpg

LM Start	1.29	Rating **	M	Issue No.	41
LM End	1.29	Issue Type +	En	Location *	
Category	Supplemental			GPS Latitude/Longitude	
				Start	End
Item	DWR UCIP Field Study			38.583728 °	38.583728 °
				-121.340178 °	-121.340178 °
DWR ID	25449				
Comment Code					
Inspector Comment					
FS_ID:50053 DS_ID:25449 EP_NO: N/A Repair Type: Non-Urgent Crossing Status: Indicator Found UCIP Comments: FIELD_STRUCT_DESC: 3-inch plastic vinyl (PVC) conduit chlorine line sleeved through steel pipe through the right bank of the levee, 2 feet below crown. Contact: Sacramento Regional Office 875-9400; Oscar Starks (Supervisor) 916-204-5143; Troy Shurock 916-599-2413. (3-inch line authorized under Permit No. 4535-1964, Northeast Sacramento County Sanitation District) FS Date: 4/1/2016

WS View - underground service alert (USA) markings indicating pipe alignment.

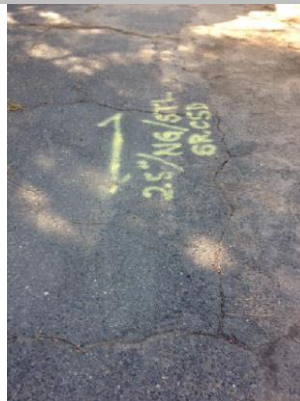
Photo 2 of 3 : UCIP_FA_2018_50053_75903.jpg

USA markings indicate 2.5-inch steel line.

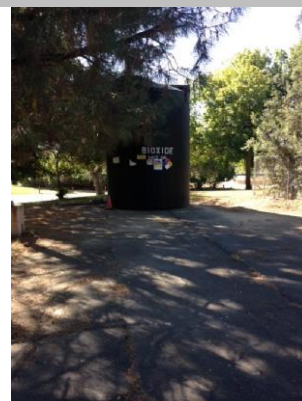
Photo 3 of 3 : UCIP_FA_2018_50053_75904.jpg

LM Start	1.29	Rating **	M	Issue No.	41 (cont)	
LM End	1.29	Issue Type +	En	Location *		
Category	Supplemental			GPS Latitude/Longitude		
				Start		End
Item	DWR UCIP Field Study			38.583728 °		38.583728 °
				-121.340178 °		-121.340178 °
DWR ID	25449					
Comment Code						
Inspector Comment						
FS_ID:50053 DS_ID:25449 EP_NO: N/A Repair Type: Non-Urgent Crossing Status: Indicator Found UCIP Comments: FIELD_STRUCT_DESC: 3-inch plastic vinyl (PVC) conduit chlorine line sleeved through steel pipe through the right bank of the levee, 2 feet below crown. Contact: Sacramento Regional Office 875-9400; Oscar Starks (Supervisor) 916-204-5143; Troy Shurock 916-599-2413. (3-inch line authorized under Permit No. 4535-1964, Northeast Sacramento County Sanitation District) FS Date: 4/1/2016

Storage tank located on WS.

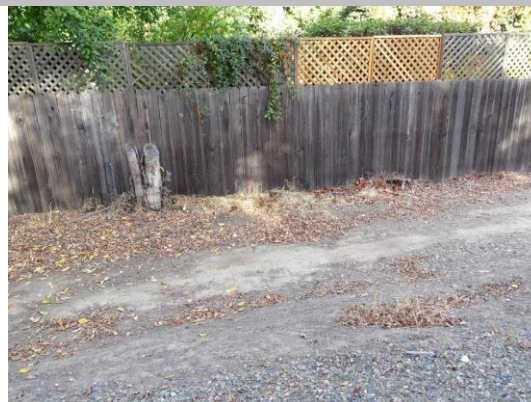
Photo 1 of 1 : FA_2018_NA0001_61_26_20181029_00048.jpg

LM Start	1.29	Rating **	N	Issue No.	26
LM End	1.29	Issue Type +	Ma	Location *	LS
Category	Earthen Levee			GPS Latitude/Longitude	
				Start	End
Item	Trim / Thin Trees			38.583713 °	38.583713 °
				-121.340287 °	-121.340287 °
DWR ID	DWR_NA0001_10_f_2018_26				
Comment Code					
T5 : Tree stumps.					
Inspector Comment					
Two tree stumps on the levee easement need to be removed.

View of tree stumps on levee easement. Fall 2018

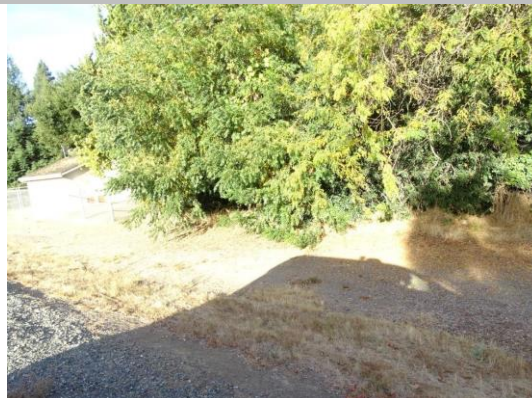
Photo 1 of 1 : FA_2018_NA0001_61_25_20181029_00047.jpg

LM Start	1.51	Rating **	M	Issue No.	25
LM End	1.51	Issue Type +	En	Location *	LS
Category	Earthen Levee			GPS Latitude/Longitude	
				Start	End
Item	Encroachments			38.581745 °	38.581745 °
				-121.343357 °	-121.343357 °
DWR ID	DWR_NA0001_10_f_2018_25				
Comment Code					
TR : Tree or limb					
Inspector Comment					
Landowner vegetation partially obstructs access.

View of vegetation over levee easement. Fall 2018

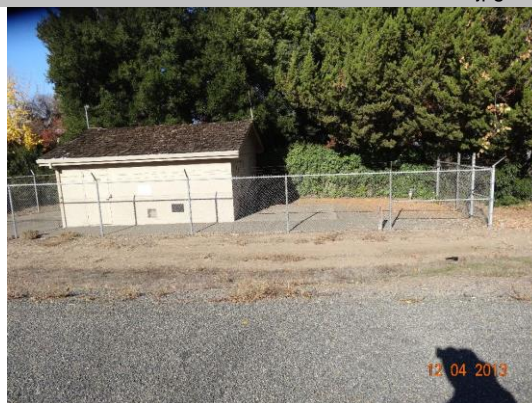
Photo 1 of 3 : UCIP_FA_2018_41548_54880.jpg

LM Start	1.53	Rating **	M	Issue No.	42
LM End	1.53	Issue Type +	En	Location *	
Category	Supplemental			GPS Latitude/Longitude	
				Start	End
Item	DWR UCIP Field Study			38.581594°	38.581594°
				-121.343622°	-121.343622°
DWR ID	24419				
Comment Code					
Inspector Comment					
FS_ID:41548 DS_ID:24419 EP_NO: N/A Repair Type: Non-Urgent Crossing Status: Found UCIP Comments: Need to find out the status of crossing--unable to determine if crossing is being used. FIELD_STRUCT_DESC: 24-inch pipe of unknown purpose or material through the levee, 7 feet below the crown. Concrete inspection box at waterside (WS) toe. FS Date: 12/4/2013

Structure located on landward side.

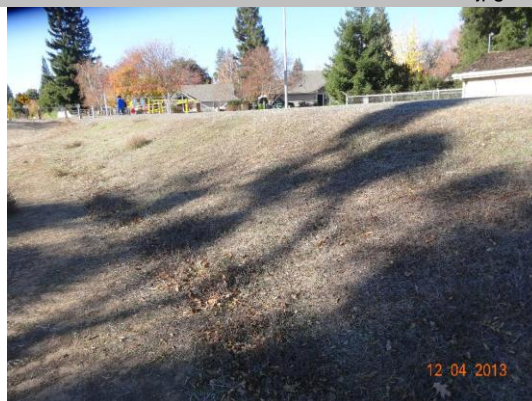
Photo 2 of 3 : UCIP_FA_2018_41548_54881.jpg

LM Start	1.53	Rating **	M	Issue No.	42 (cont)	
LM End	1.53	Issue Type +	En	Location *		
Category	Supplemental			GPS Latitude/Longitude		
				Start	End	
Item	DWR UCIP Field Study			38.581594 °	38.581594 °	
				-121.343622 °	-121.343622 °	
DWR ID	24419					
Comment Code						
Inspector Comment						
FS_ID:41548 DS_ID:24419 EP_NO: N/A Repair Type: Non-Urgent Crossing Status: Found UCIP Comments: Need to find out the status of crossing--unable to determine if crossing is being used. FIELD_STRUCT_DESC: 24-inch pipe of unknown purpose or material through the levee, 7 feet below the crown. Concrete inspection box at waterside (WS) toe. FS Date: 12/4/2013

View of waterward side.

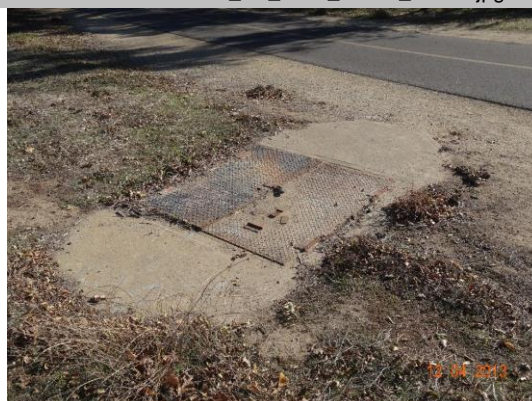
Photo 3 of 3 : UCIP_FA_2018_41548_54883.jpg

Concrete box located on waterward side near paved trail.

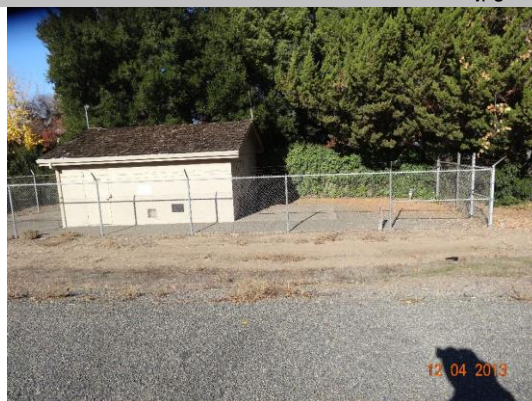
Photo 1 of 3 : UCIP_FA_2018_41546_57290.jpg

LM Start	1.53	Rating **	M	Issue No.	43	
LM End	1.53	Issue Type +	En	Location *		
Category	Supplemental			GPS Latitude/Longitude		
				Start	End	
Item	DWR UCIP Field Study			38.581588 °	38.581588 °	
				-121.343631 °	-121.343631 °	
DWR ID	24101					
Comment Code						
Inspector Comment						
FS_ID:41546						
DS_ID:24101						
EP_NO: N/A						
Repair Type: Non-Urgent						
Crossing Status: Found						
UCIP Comments: Need to determine the status of crossing--unable to determine if crossing is still active.						
FIELD_STRUCT_DESC: 8-inch pipe of unknown purpose or material through the levee at unknown depth. Concrete inspection box on the landside (LS) slope. [Additional Reference(s): DWR Levee Log, 2002]						
FS Date: 12/4/2013

Structure located on waterward side.

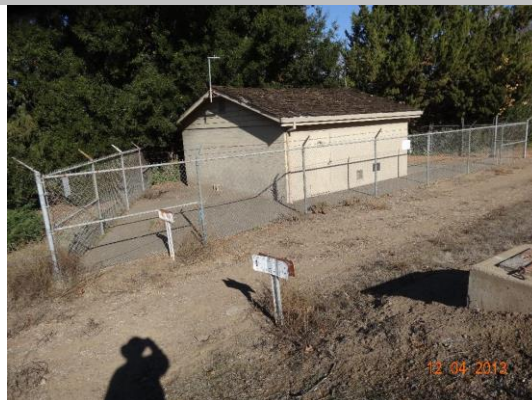
Photo 2 of 3 : UCIP_FA_2018_41546_57289.jpg

View of landward side--chlorine line adjacent to 8-inch pipe.

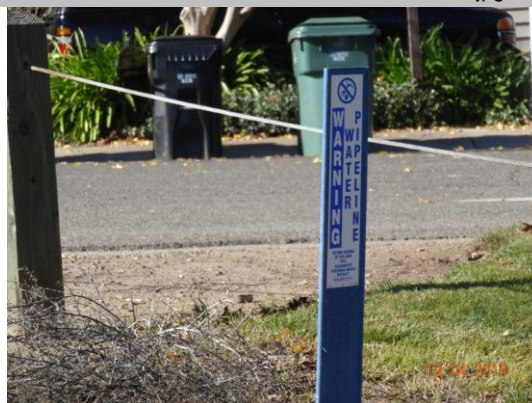
Photo 1 of 2 : UCIP_FA_2018_30575_56338.jpg

LM Start	1.61	Rating **	M	Issue No.	44
LM End	1.61	Issue Type +	En	Location *	
Category	Supplemental			GPS Latitude/Longitude	
				Start	End
Item	DWR UCIP Field Study			38.580991 °	38.580991 °
				-121.344917 °	-121.344917 °
DWR ID	24822				
Comment Code					
Inspector Comment					
FS_ID:30575					
DS_ID:24822					
EP_NO: N/A					
Repair Type: Non-Urgent					
Crossing Status: Indicator Found					
UCIP Comments: 2nd marker visible on landward side at levee mile					
1.63 (38.581564 -121.343806).					
FIELD_STRUCT_DESC: Marker indicating water line located on					
landside (LS) toe. Unable to determine if line runs parallel to levee or if					
line crosses levee. Unable to find permit for work.					
FS Date: 12/4/2013

Waterline marker at levee mile 1.63.

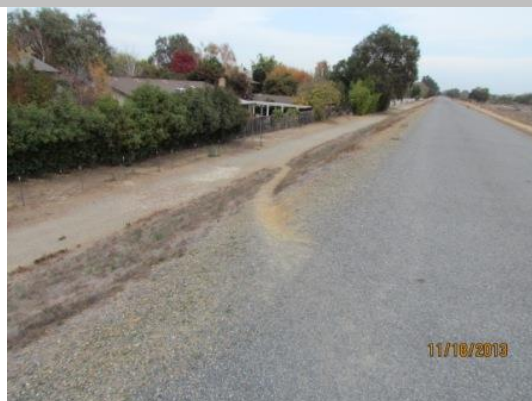
Photo 1 of 1 : FA_2018_NA0001_61_7_20180911_00002.jpg

LM Start	2.41	Rating **	A/W	Issue No.	7
LM End	2.41	Issue Type +	Ma	Location *	LS
Category	Earthen Levee			GPS Latitude/Longitude	
				Start	End
Item	Slope Stability			38.575126°	38.575126°
				-121.357575°	-121.357575°
DWR ID	DWR_NA0001_10_f_2013_7				
Comment Code					
S2 : Repair the levee slope damaged by foot traffic and prevent access where possible.					
Inspector Comment

View of the pathway on the landside levee slope.

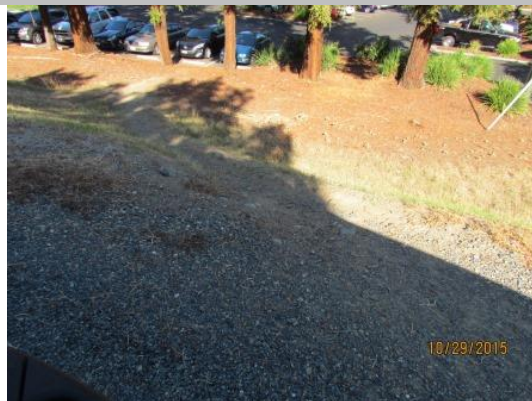
Photo 1 of 1 : FA_2018_NA0001_61_21_20180911_00004.jpg

LM Start	3.49	Rating **	A/W	Issue No.	21
LM End	3.49	Issue Type +	Ma	Location *	LS
Category	Earthen Levee			GPS Latitude/Longitude	
				Start	End
Item	Slope Stability			38.569484 °	38.569484 °
				-121.375841 °	-121.375841 °
DWR ID	DWR_NA0001_10_f_2015_21				
Comment Code					
S2 : Repair the levee slope damaged by foot traffic and prevent access where possible.					
Inspector Comment

View of the footpath on the landside levee slope.

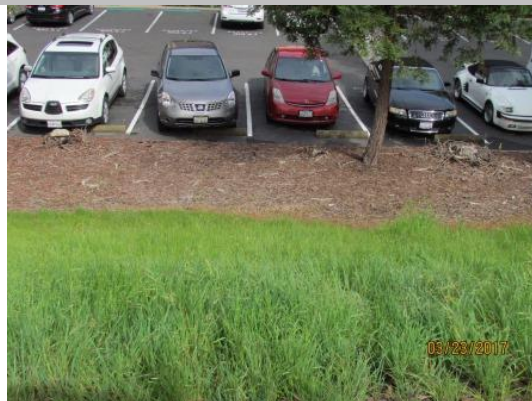
Photo 1 of 1 : FA_2018_NA0001_61_29_20180911_00007.jpg

LM Start	3.56	Rating **	N	Issue No.	29
LM End	3.56	Issue Type +	Ma	Location *	LS
Category	Earthen Levee			GPS Latitude/Longitude	
				Start	End
Item	Trim / Thin Trees			38.569242 °	38.569242 °
				-121.377169 °	-121.377169 °
DWR ID	DWR_NA0001_10_s_2017_29				
Comment Code					
T5 : Tree stumps.					
Inspector Comment					
Three tree stumps within ten feet of levee toe.

View of the tree stumps within the levee easement.

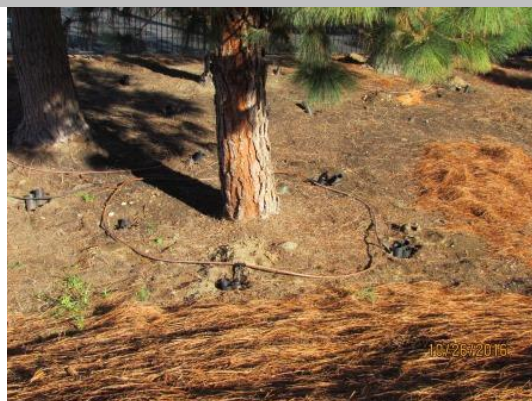
Photo 1 of 1 : FA_2018_NA0001_61_27_20180911_00005.jpg

LM Start	3.76	Rating **	M	Issue No.	27
LM End	3.76	Issue Type +	En	Location *	LS
Category	Earthen Levee			GPS Latitude/Longitude	
				Start	End
Item	Encroachments			38.568413 °	38.568413 °
				-121.380711 °	-121.380711 °
DWR ID	DWR_NA0001_10_f_2016_27				
Comment Code					
LI : Landscape Irrigation					
Inspector Comment

View of the landscaping irrigation at the landside levee toe.

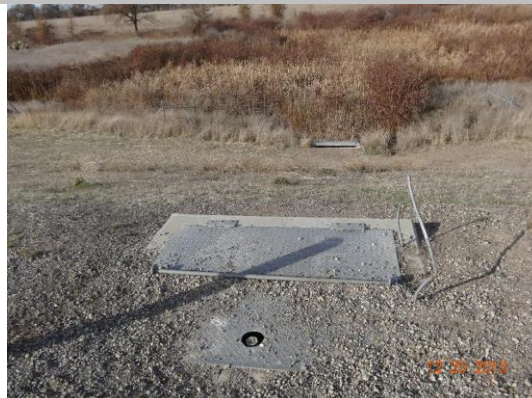
Photo 1 of 3 : UCIP_FA_2018_31310_57345.jpg

Comment Code					
Inspector Comment					
FS_ID:31310 DS_ID:24823 EP_NO: N/A Repair Type: Non-Urgent Crossing Status: Found UCIP Comments: 08/16/2017 DWR Deferred Maintenance Project (DMP), Vince Rodriguez, forwarded email received from Tim Kerr, General Manager of American River Flood Control District (ARFCD) with file "DWR Eligible Pipes Found in ARFCD" from ARFCD that shows the ownership and location of the pipes Tim Kerr investigated. Owner of this crossing is identified as the City of Sacramento, ARFCD Staff Notes indicate Claire Ave. (DWR UCIP - O. Magana) 12/20/2013 no permit found--owner? (unauthorized?) (DWR UCIP - O. Magana) FIELD_STRUCT_DESC: 24-inch pipe through the levee at unknown depth. Concrete box located on waterside (WS) shoulder. Concrete wall located on waterside (WS) and landside (LS). Siphon breaker inside concrete service box located on WS shoulder. (no permit has been identified authorizing this structure, structure is owned by the City of Sacramento) FS Date: 12/20/2013

View of waterward side.

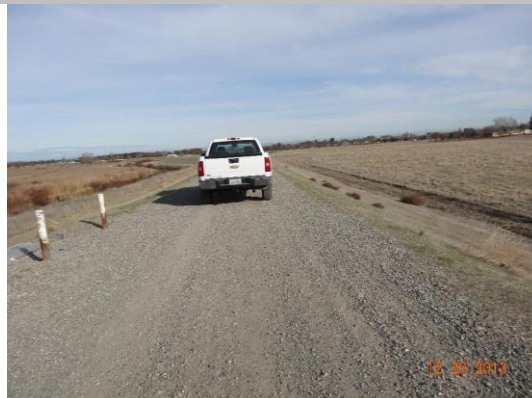
Photo 2 of 3 : UCIP_FA_2018_31310_57342.jpg

View of levee crown at crossing.

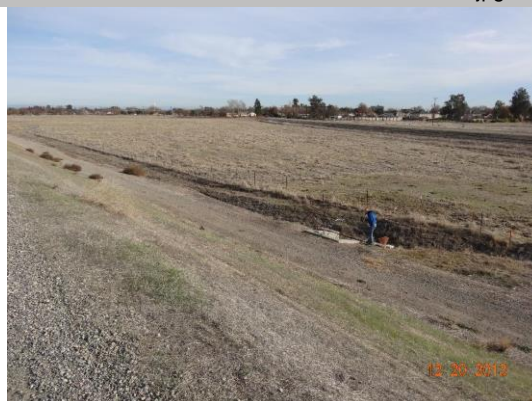
Photo 3 of 3 : UCIP_FA_2018_31310_57343.jpg

View of landward side.

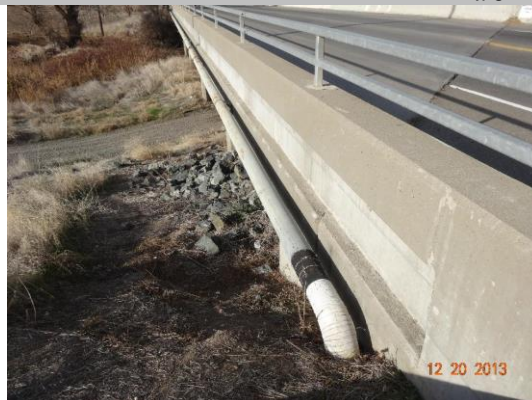
Photo 1 of 1 : UCIP_FA_2018_31311_57346.jpg

LM Start	0.48	Rating **	M	Issue No.	8	
LM End	0.48	Issue Type +	En	Location *		
Category	Supplemental			GPS Latitude/Longitude		
				Start	End	
Item	DWR UCIP Field Study			38.666585 °	38.666585 °	
				-121.451009 °	-121.451009 °	
DWR ID	24824					
Comment Code						
Inspector Comment						
FS_ID:31311 DS_ID:24824 EP_NO: N/A Repair Type: Non-Urgent Crossing Status: Found UCIP Comments: owner? permit? (unauthorized?) FIELD_STRUCT_DESC: 6-inch conduit through levee at unknown depth. Conduit extends across the channel, attached to bridge. FS Date: 12/20/2013

Crossing visible on waterward side.

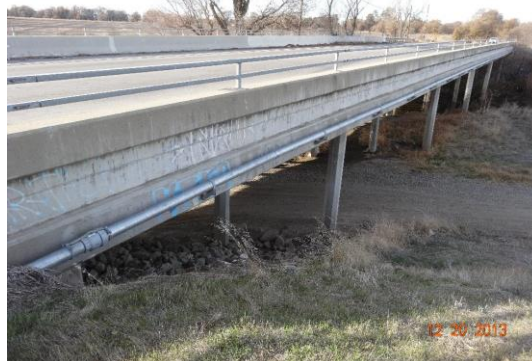
Photo 1 of 1 : UCIP_FA_2018_31312_57347.jpg

LM Start	0.49	Rating **	M	Issue No.	9
LM End	0.49	Issue Type +	En	Location *	
Category	Supplemental			GPS Latitude/Longitude	
				Start	End
Item	DWR UCIP Field Study			38.666745 °	38.666745 °
				-121.450918 °	-121.450918 °
DWR ID	24825				
Comment Code					
Inspector Comment					
FS_ID:31312 DS_ID:24825 EP_NO: N/A Repair Type: Non-Urgent Crossing Status: Found UCIP Comments: owner? permit? (unauthorized?) FIELD_STRUCT_DESC: 4-inch communication conduit of unknown material through levee at unknown depth. Conduit extends across the channel, attached to bridge. FS Date: 12/20/2013

Conduit attached to the upstream face of Rio Linda Blvd Bridge.

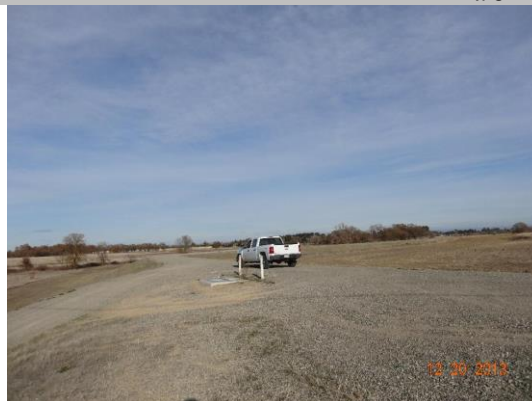
Photo 1 of 3 : UCIP_FA_2018_31313_57349.jpg

Comment Code					
Inspector Comment					
FS_ID:31313 DS_ID:24826 EP_NO: N/A Repair Type: Non-Urgent Crossing Status: Found UCIP Comments: 08/16/2017 DWR Deferred Maintenance Project (DMP), Vince Rodriguez, forwarded email received from Tim Kerr, General Manager of American River Flood Control District (ARFCD) with file "DWR Eligible Pipes Found in ARFCD" from ARFCD that shows the ownership and location of the pipes Tim Kerr investigated. Owner of this crossing is identified as the City of Sacramento, ARFCD Staff Notes indicate Rio Linda, just Upstream. (DWR UCIP - O. Magana) 12/20/2013 owner? permit? (unauthorized?) (DWR UCIP - O. Magana) FIELD_STRUCT_DESC: 24-inch (estimate only field verify) storm drain pipe through levee at an unknown depth. Concrete headwalls with debris screens located on waterside (WS) and landside (LS). Concrete box with protective posts located on WS shoulder. (no permit has been identified authorizing this structure, structure is owned by the City of Sacramento) FS Date: 12/20/2013

View of levee crown at crossing.

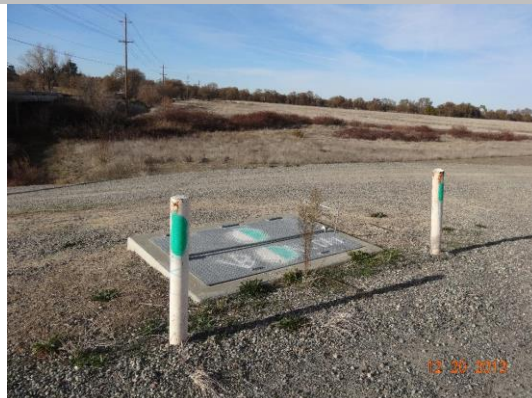
Photo 2 of 3 : UCIP_FA_2018_31313_57348.jpg

Concrete vault with protective posts located on waterward shoulder.

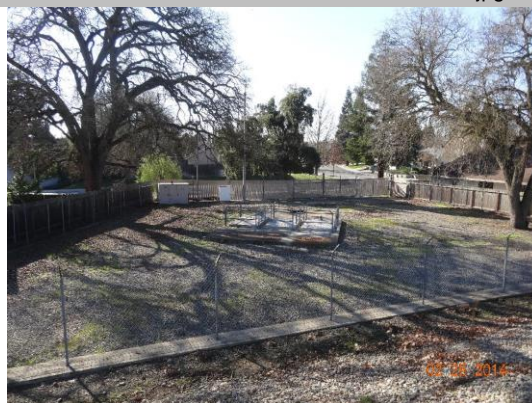
Photo 1 of 3 : UCIP_FA_2018_46995_56234.jpg

Comment Code						
Inspector Comment						
FS_ID:46995 DS_ID:24830 EP_NO: N/A Repair Type: Non-Urgent Crossing Status: Indicator Found UCIP Comments: Unable to confirm pipe size--need to contact owner to obtain additional information on crossing. FIELD_STRUCT_DESC: [SRCSD Facility N16 NE Siphon Outlet] 1 of 3: 48-inch reinforced concrete (RC) drainage pipe through the levee, 11 feet below crown. Pipe crosses levee at an angle. Sacramento Regional County Sanitation District (SRCSD) Facility N16 NE Siphon Outlet located on landside (LS). Facility is fenced off. Inside facility are 3 concrete boxes with 3 manholes. (three 48-inch pipes authorized under Permit No. 12144, 1978-SRCSD; cathodic protection for 48-inch pipe authorized under 12144-A, 1983-SRCSD) FS Date: 2/25/2014

Concrete vault located on landward side.

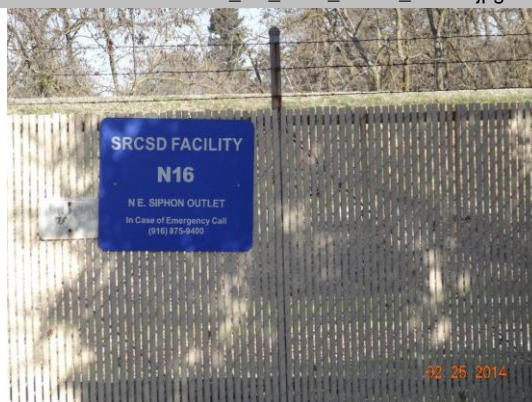
Photo 2 of 3 : UCIP_FA_2018_46995_56235.jpg

SRCSD Facility N16, NE Siphon Outlet, sign visible from Mira Del Rio Drive.

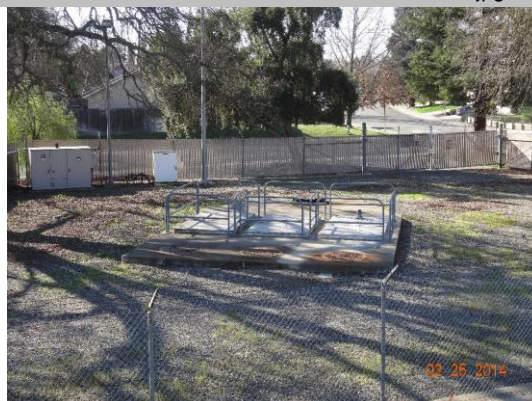
Photo 3 of 3 : UCIP_FA_2018_46995_56233.jpg

Manholes located on landward side.

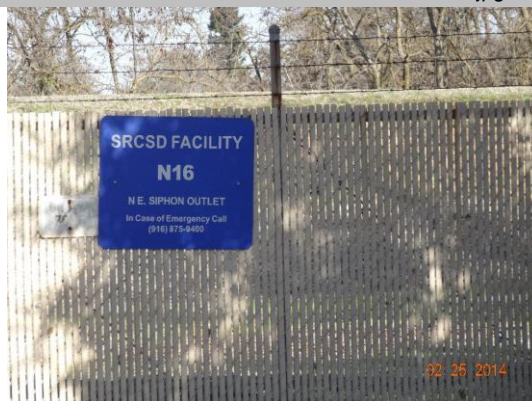
Photo 1 of 3 : UCIP_FA_2018_30540_56232.jpg

Comment Code					
Inspector Comment					
FS_ID:30540 DS_ID:24829 EP_NO: N/A Repair Type: Non-Urgent Crossing Status: Indicator Found UCIP Comments: Unable to confirm pipe size--need to contact owner to obtain additional information on crossing. FIELD_STRUCT_DESC: [SRCSD Facility N16 NE Siphon Outlet] 2 of 3: 48-inch reinforced concrete (RC) drainage pipe through the levee, 11 feet below crown. Pipe crosses levee at an angle. Sacramento Regional County Sanitation District (SRCSD) Facility N16 NE Siphon Outlet located on landside (LS). Facility is fenced off. Inside facility are 3 concrete boxes with 3 manholes. (three 48-inch pipes authorized under Permit No. 12144, 1978-SRCSD; cathodic protection for 48-inch pipe authorized under 12144-A, 1983-SRCSD) FS Date: 2/25/2014

SRCSD Facility N16, NE Siphon Outlet, sign visible from Mira Del Rio Drive.

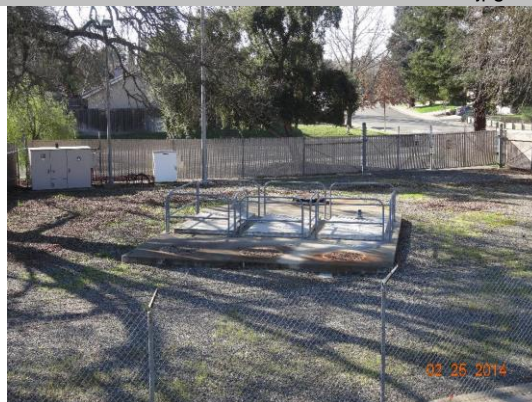
Photo 2 of 3 : UCIP_FA_2018_30540_56230.jpg

Manholes visible on landward side.

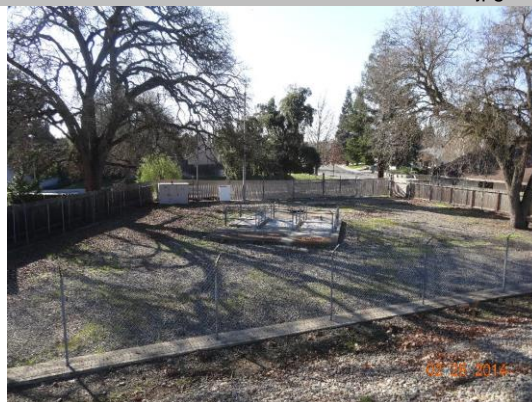
Photo 2 of 3 : UCIP_FA_2018_46994_56228.jpg

Comment Code						
Inspector Comment						
FS_ID:46994 DS_ID:24828 EP_NO: N/A Repair Type: Non-Urgent Crossing Status: Indicator Found UCIP Comments: Unable to confirm pipe size--need to contact owner to obtain additional information on crossing. FIELD_STRUCT_DESC: [SRCSD Facility N16 NE Siphon Outlet] 3 of 3: 48-inch reinforced concrete (RC) drainpipe through the levee at 11.0 feet below crown. Pipe crosses levee at an angle. Sacramento Regional County Sanitation District (SRCSD) Facility N16 NE Siphon Outlet located on landside (LS). Facility is fenced off. Inside facility are 3 concrete boxes with 3 manholes. (three 48-inch pipes authorized under Permit No. 12144, 1978-SRCSD; cathodic protection for 48-inch pipe authorized under 12144-A, 1983-SRCSD) FS Date: 2/25/2014

Concrete vault for 3 crossings located on landward side.
